# Manhole Inspection Summary

Manhole # S33II2004MH

Insp Date: **12/18/06 11:16 AM**

**Location** Address: **6300 BOXWOOD RD**

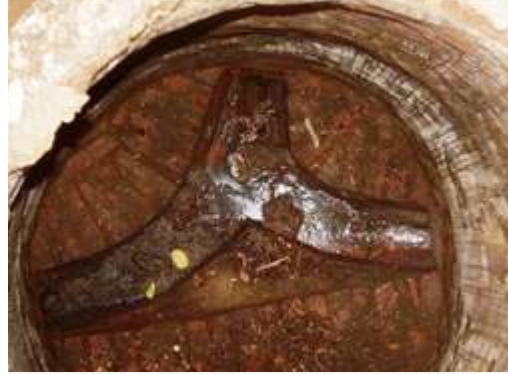
Top View

Bench and Channel debris.

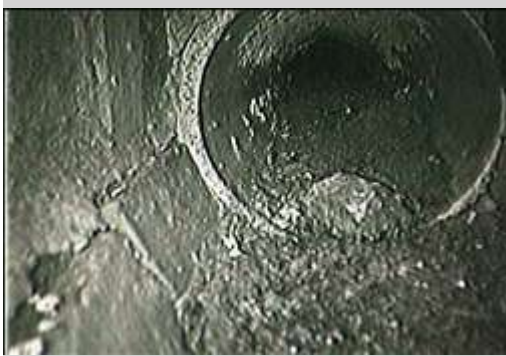
Inside the I8

Corbel deterioration and infiltration.

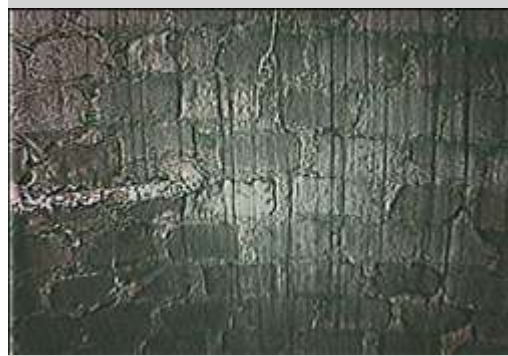
Defect

Frame offset. Adjustment deterioration, loose brick and infiltration. Corbel and Barrel infiltration.

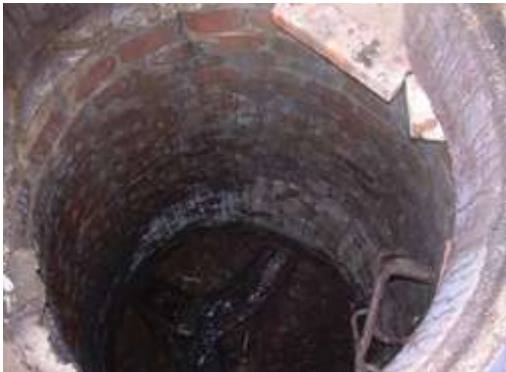
Defect

Frame offset. Adjustment deterioration, loose brick and infiltration. Corbel and Barrel infiltration - other side.

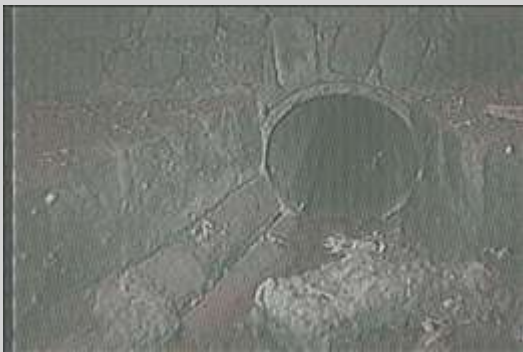
### 8 in. Circular Gravity Sewer Pipe Out @ 12 O'Clock

Barrel deterioration and infiltration. Channel deterioration.

Infiltration: **Evidence** Pipe Seal Cond: **Cracked**

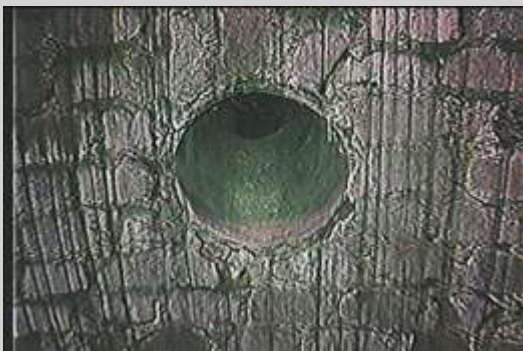
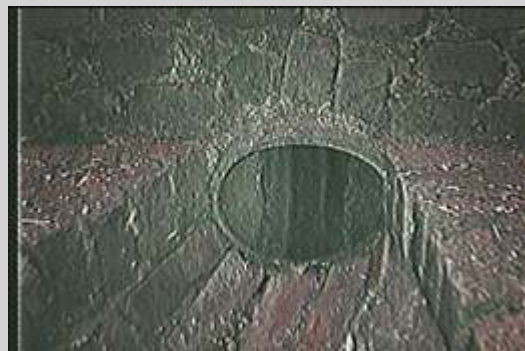
### 8 in. Circular Gravity Sewer Pipe In @ 2 O'Clock

Barrel deterioration and infiltration. Channel deterioration.

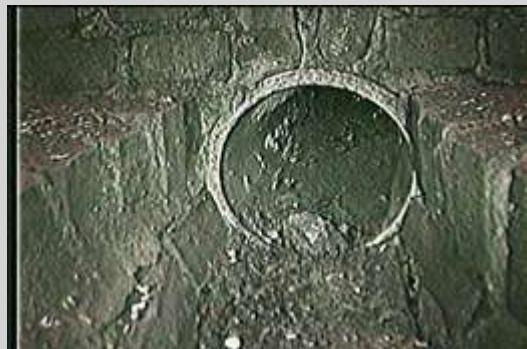
Pipe In @ 8 O'Clock

Channel deterioration.

Deposits: ☐ None ☒ **Mud** ☐ Sludge ☒ **Debris** ☐ Grease

Silt Depth: **2** (in.) Deposits Extent: **Medium**
